**Flood Control Project Maintenance
Levee Inspections**
LMA District Cover Sheet
Spring 2011 Levee Inspection Results

American River Flood Control District

Spring 2011 Levee Inspection Results

Levee Inspection Report By Mile - Spring 2011

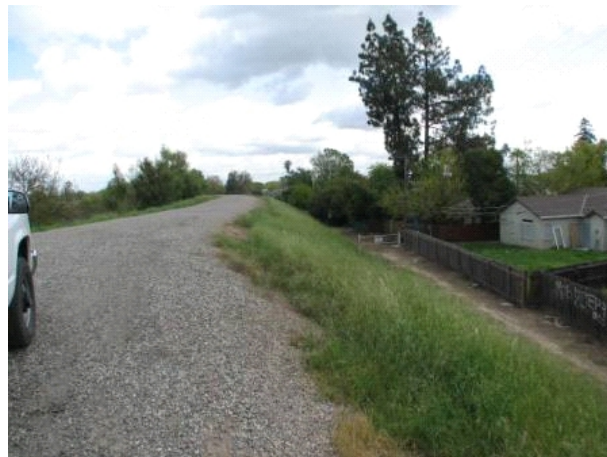
jeto_s_20110413_394.jpg

04/13/2011 Mowing has not started in this unit.

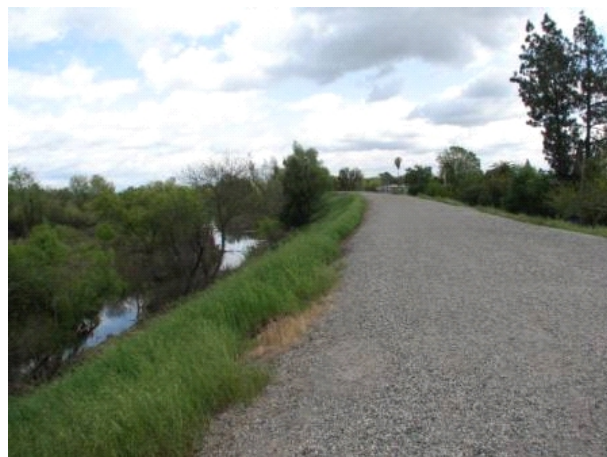
jeto_s_20110413_395.jpg

Levee Mile Report Line	7
Start Levee Mile	0.69
End Levee Mile	1.21
Location	Water Side
Category	Earthen Levee
Item	Vegetation

04/13/2011 Mowing has not started in this unit.

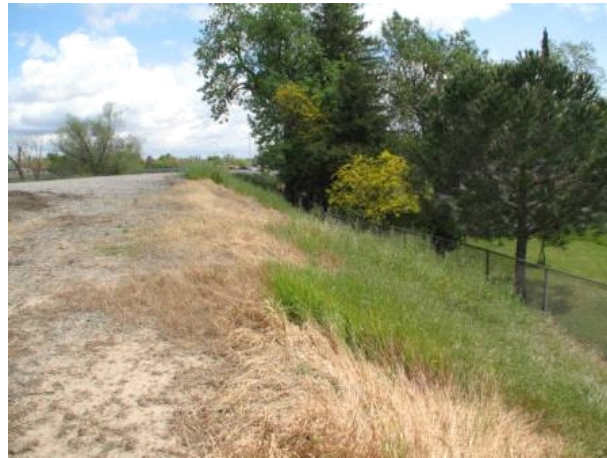
jeto_s_20110413_397.jpg

04/13/2011 Mowing has not yet started in this unit.

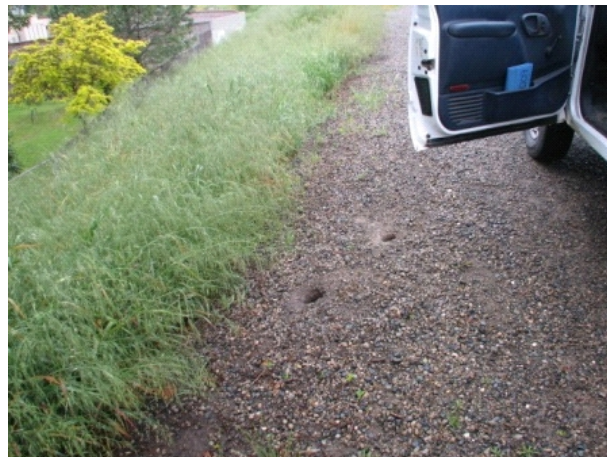
jeto_s_20110301_300.jpg

Levee Mile Report Line	15
Start Levee Mile	1.26
End Levee Mile	1.26
Location	Crown
Category	Earthen Levee
Item	Animal Control

Rodent burrows on levee crown.

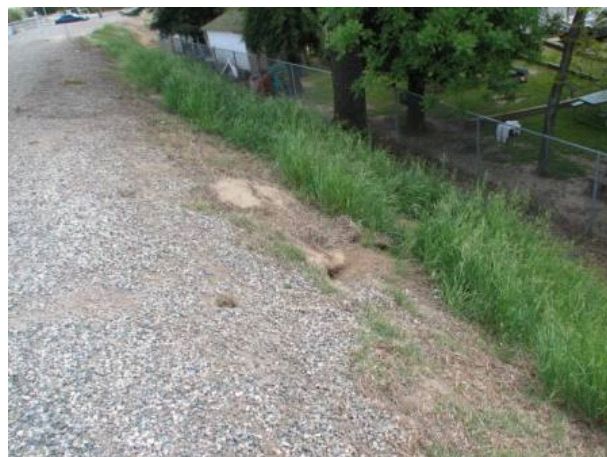
jeto_s_20110413_398.jpg

Levee Mile Report Line	15
Start Levee Mile	1.26
End Levee Mile	1.26
Location	Crown
Category	Earthen Levee
Item	Animal Control

04/13/2011 Fresh burrows present, rodents are also present.

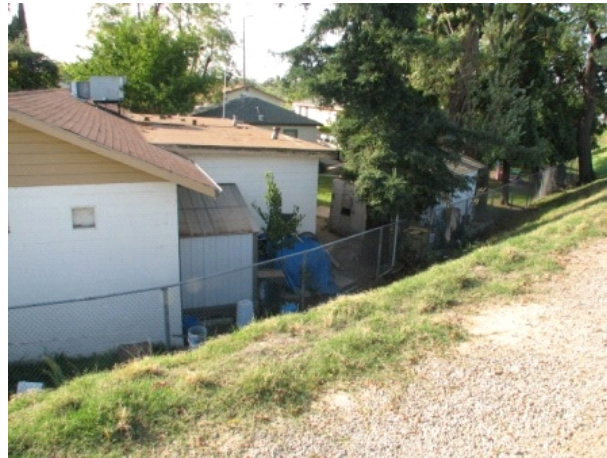
jeto_s_20110301_297.jpg

Fall 2009 photo: Buildings and fence near levee toe.

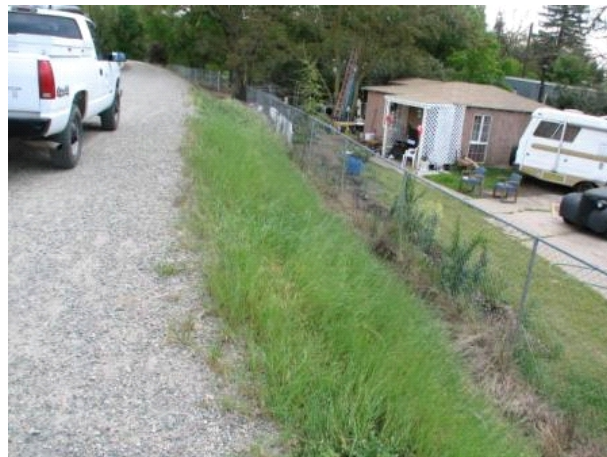
jeto_s_20110413_401.jpg

Levee Mile Report Line	17
Start Levee Mile	1.31
End Levee Mile	1.31
Location	Land Side
Category	Earthen Levee
Item	Vegetation

04/13/2011 Mowing has not yet started in this unit.

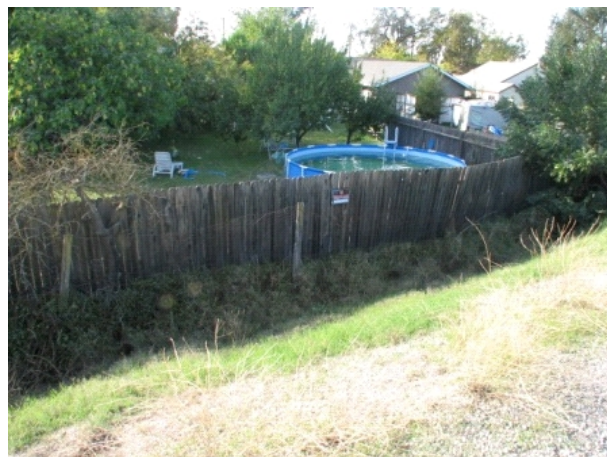
jeto_s_20110301_296.jpg

Levee Mile Report Line	20
Start Levee Mile	1.38
End Levee Mile	1.38
Location	Land Side
Category	Earthen Levee
Item	Encroachments

Fall 2009 photo: Wooden and wire fence are within 10-ft of levee toe.

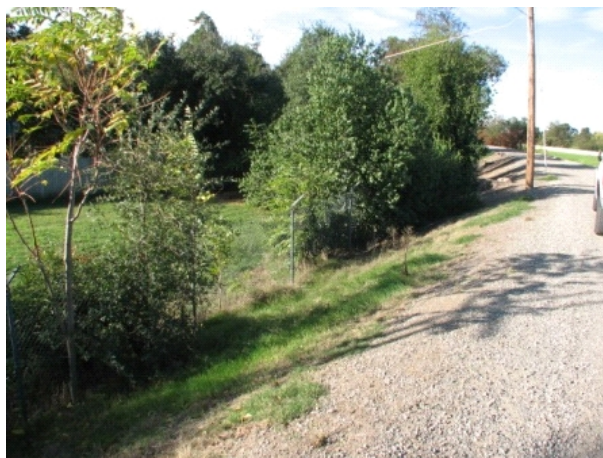
jeto_s_20110301_295.jpg

Fall 2009 photo: Photinias and other plants planted near levee toe.

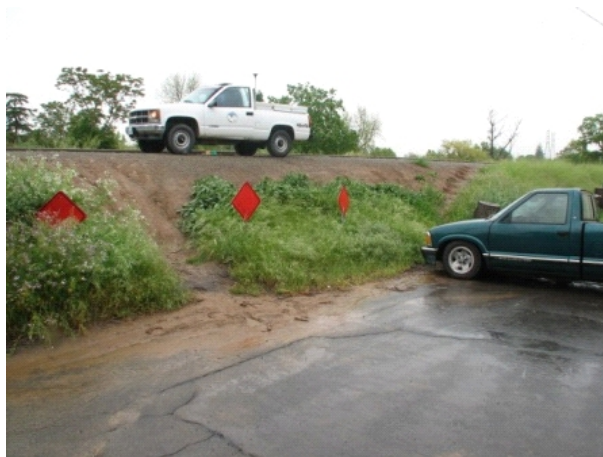
jeto_s_20110301_303.jpg

Levee Mile Report Line	28
Start Levee Mile	1.58
End Levee Mile	1.58
Location	Land Side
Category	Earthen Levee
Item	Slope Stability

Slope stability due to foot traffic needs to be monitored.

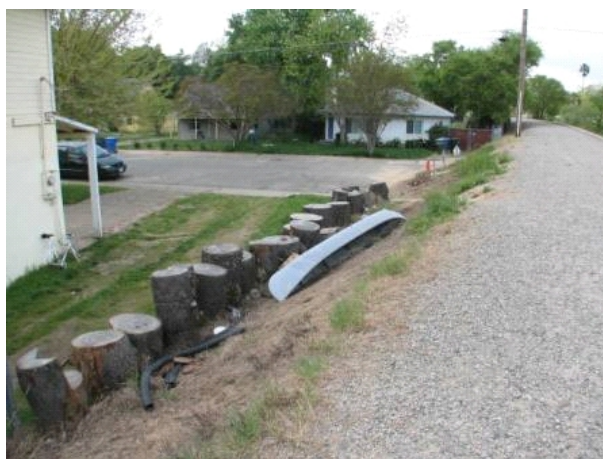
jeto_s_20110413_403.jpg

Levee Mile Report Line	29
Start Levee Mile	1.59
End Levee Mile	1.59
Location	Land Side
Category	Earthen Levee
Item	Encroachments

04/13/2011 Items appear to be stored on levee, need to be removed.

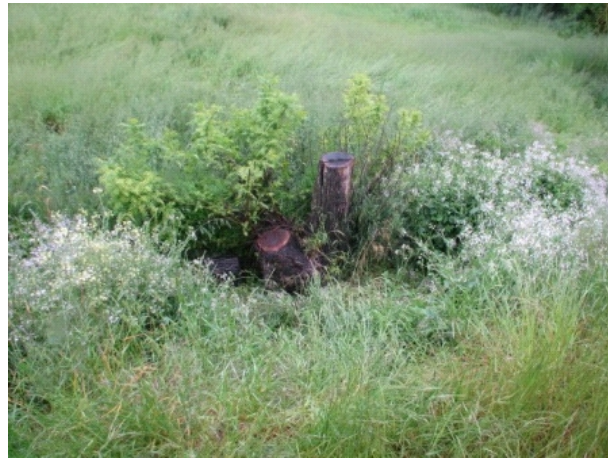
jeto_s_20110301_302.jpg

Tree stump with some new growth.

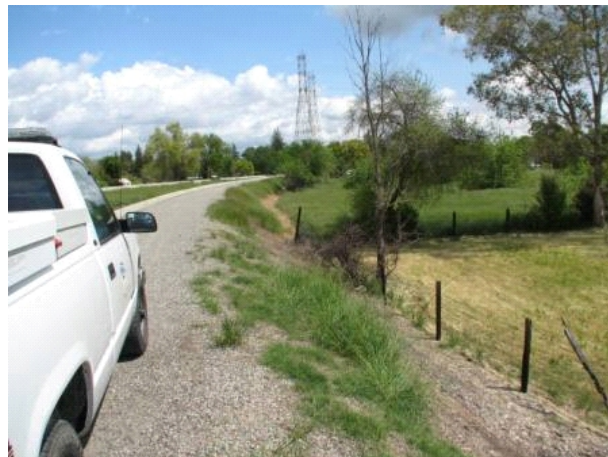
jeto_s_20110413_402.jpg

Levee Mile Report Line	32
Start Levee Mile	1.71
End Levee Mile	1.79
Location	Land Side
Category	Earthen Levee
Item	Vegetation

04/13/2011 Mowing has not yet started in this unit.

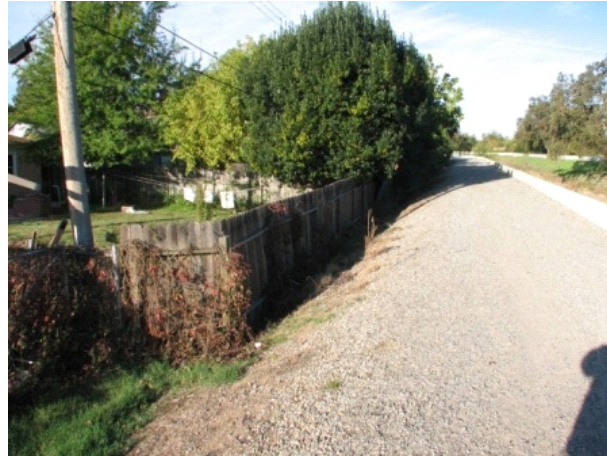
jeto_s_20110301_294.jpg

Fall 2009 photo: Wooden fence built on levee slope.

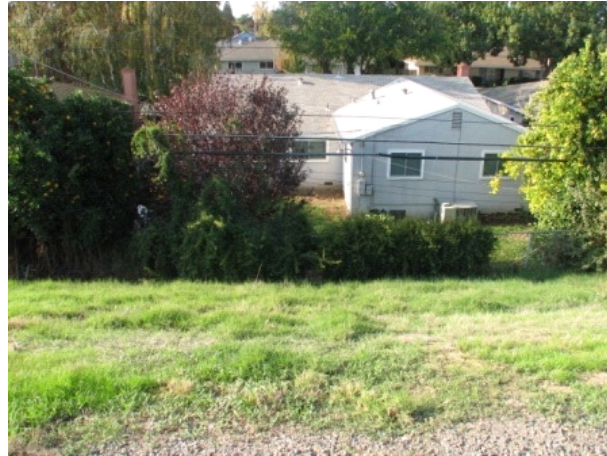
jeto_s_20110301_312.jpg

Fall 2009 photo: Landscaping within 10-ft of levee toe obstructs access and visibility.

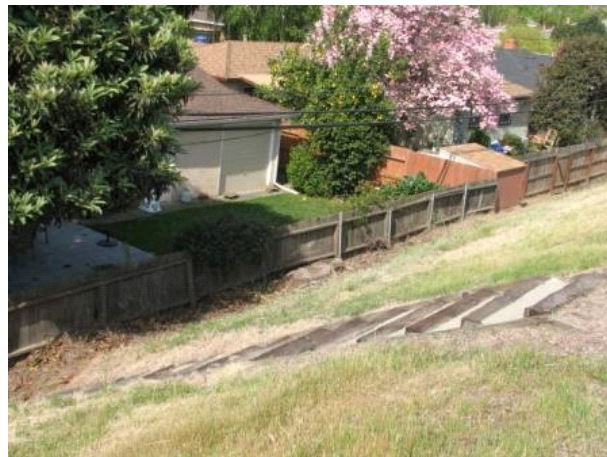
jeto_s_20110414_420.jpg

Levee Mile Report Line	34
Start Levee Mile	4.10
End Levee Mile	4.10
Location	Land Side
Category	Earthen Levee
Item	Encroachments

04/14/2011 Palms have been removed.

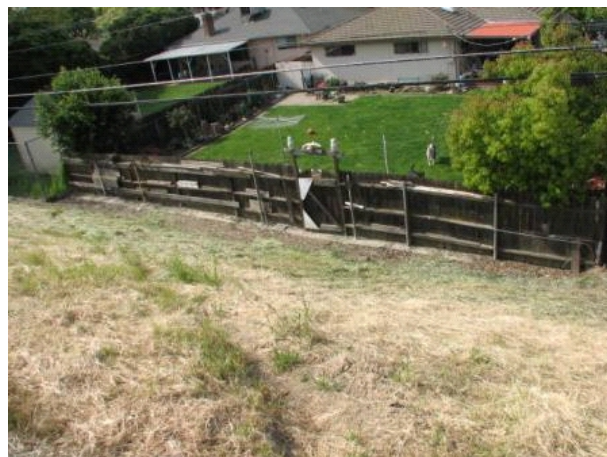
jeto_s_20110414_421.jpg

Levee Mile Report Line	42
Start Levee Mile	4.21
End Levee Mile	4.21
Location	Land Side
Category	Earthen Levee
Item	Encroachments

04/14/2011 Retaining wall has been removed.

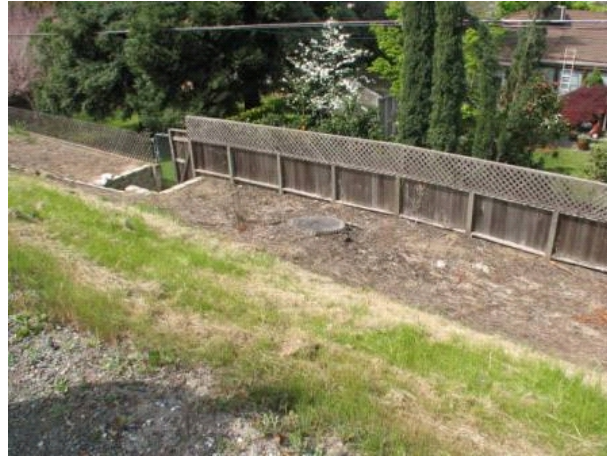
Levee Mile Report Line	104
Start Levee Mile	5.86
End Levee Mile	5.86
Location	Land Side
Category	Earthen Levee
Item	Trim / Thin Trees
04/14/2011 Large stump at toe of levee.	
jeto_s_20110414_424.jpg

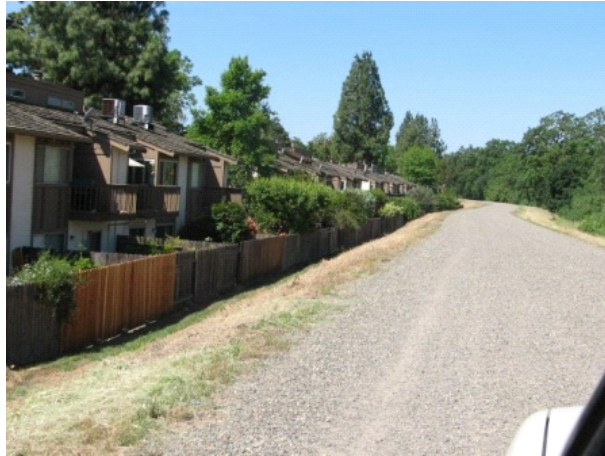
Levee Mile Report Line	201
Start Levee Mile	10.38
End Levee Mile	10.40
Location	Land Side
Category	Earthen Levee
Item	Encroachments
Wooden fence behind apartments within 10' of levee toe.	
jeto_s_20110301_310.jpg

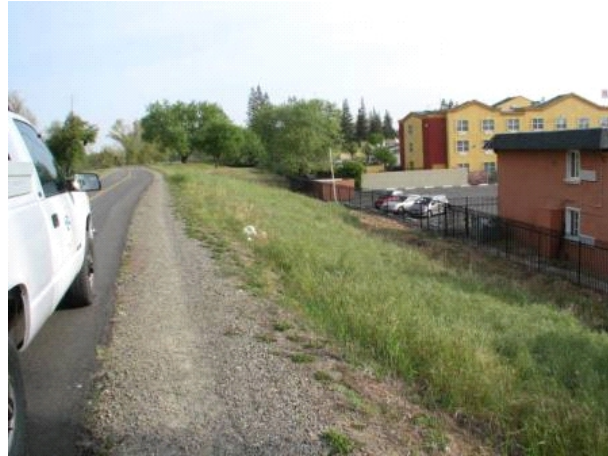
Levee Mile Report Line	1
Start Levee Mile	0.00
End Levee Mile	0.26
Location	Land Side
Category	Earthen Levee
Item	Vegetation
04/14/2011 Grass on land side needs to be mowed.	
jeto_s_20110414_414.jpg

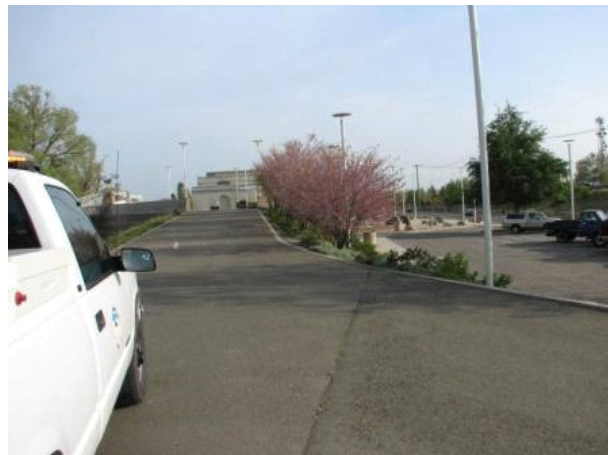
Levee Mile Report Line	4
Start Levee Mile	0.27
End Levee Mile	0.35
Location	Land Side
Category	Earthen Levee
Item	Encroachments
04/14/2011 Landscaping at City intake facility.	
jeto_s_20110414_415.jpg

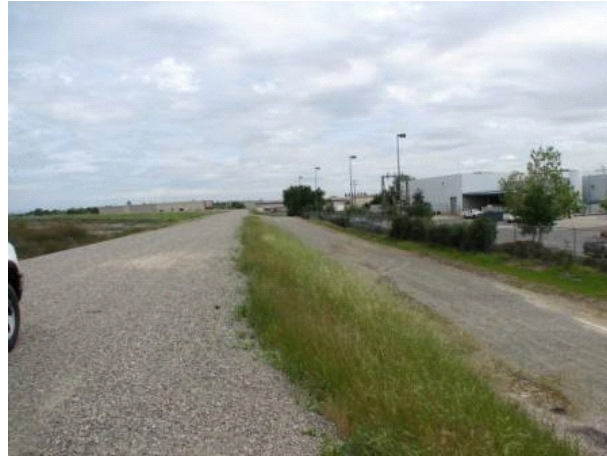
jeto_s_20110425_428.jpg

04/20/2011 Mowing has not started on this unit yet. Grass over 12" tall inhibits visibility of levee.

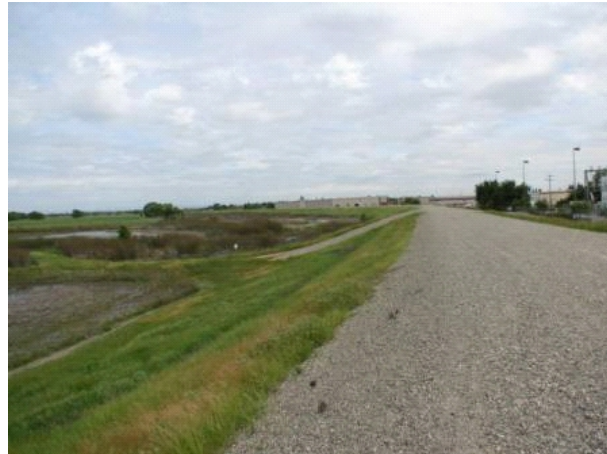
jeto_s_20110425_427.jpg

Levee Mile Report Line	2
Start Levee Mile	0.00
End Levee Mile	1.30
Location	Water Side
Category	Earthen Levee
Item	Vegetation

04/20/2011 Spring mowing has not been done on this unit yet.

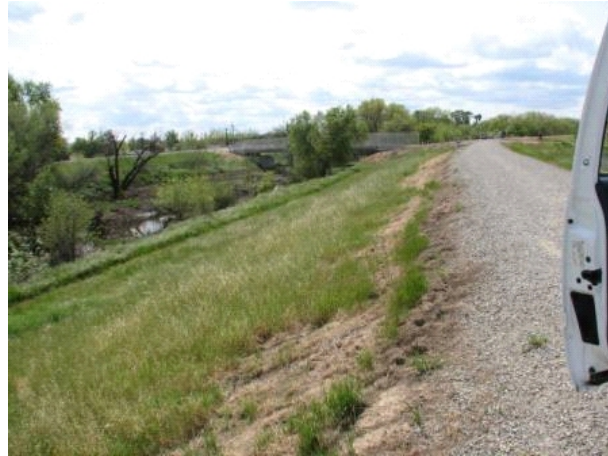
jeto_s_20110413_409.jpg

04/13/2011 Mowing has not yet started in this unit.

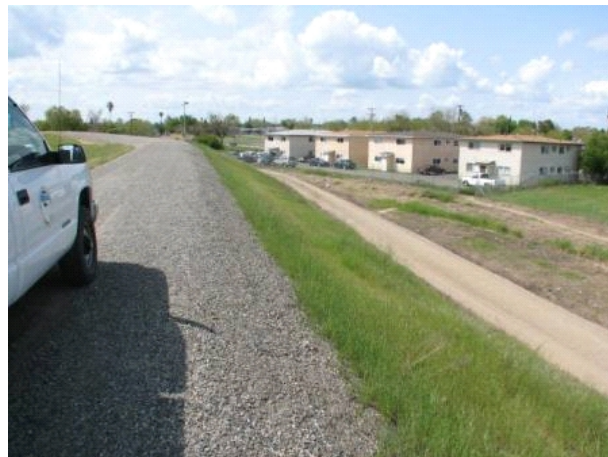
jeto_s_20110413_410.jpg

Levee Mile Report Line	2
Start Levee Mile	0.04
End Levee Mile	0.68
Location	Land Side
Category	Earthen Levee
Item	Vegetation

04/13/2011 Mowing has not yet started in this unit.

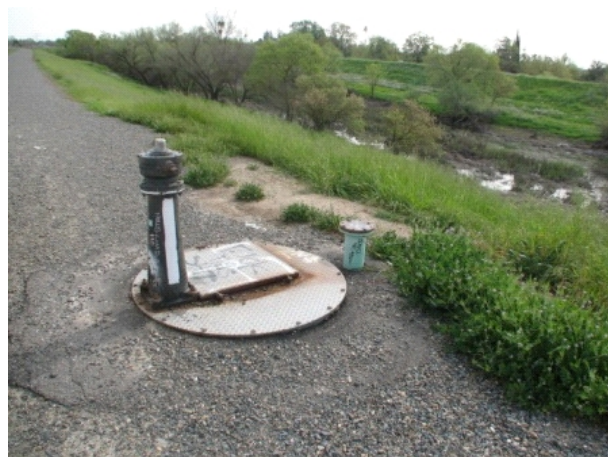
jeto_s_20110301_321.jpg

Levee Mile Report Line	3
Start Levee Mile	0.38
End Levee Mile	0.38
Location	Crown
Category	Earthen Levee
Item	Encroachments

Closure device for SS beneath channel.

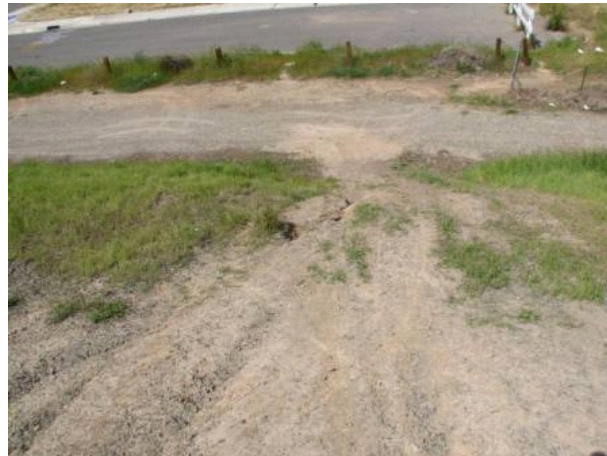
Levee Mile Report Line	4
Start Levee Mile	1.03
End Levee Mile	1.03
Location	Land Side
Category	Earthen Levee
Item	Slope Stability
04/13/2011 Foot traffic appears to be causing erosion.	
jeto_s_20110413_411.jpg

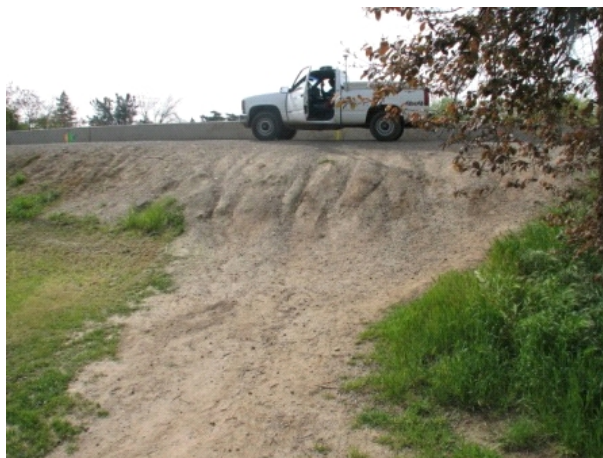
jeto_s_20110301_324.jpg

Erosion of levee slope due in part to pedestrian traffic.

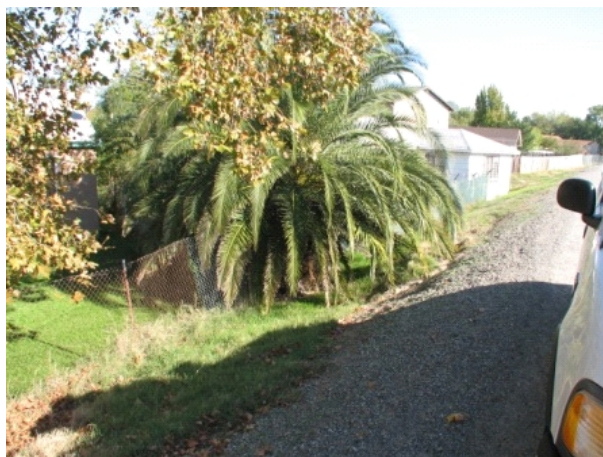
jeto_s_20110301_322.jpg

Levee Mile Report Line	23
Start Levee Mile	1.70
End Levee Mile	1.70
Location	Land Side
Category	Earthen Levee
Item	Encroachments

Fall 2009 photo of palm tree within 10-ft of the levee toe obstructs visibility and access.

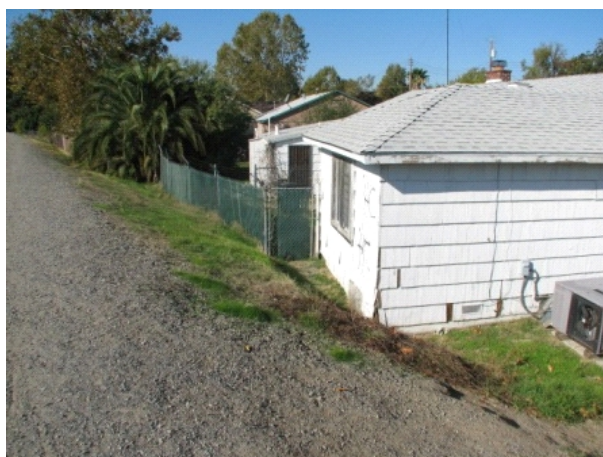
jeto_s_20110301_317.jpg

Levee Mile Report Line	24
Start Levee Mile	1.72
End Levee Mile	1.72
Location	Land Side
Category	Earthen Levee
Item	Encroachments

Fall 2009 photo of privacy fence and structure within 10-ft of the levee toe obstructs visibility and access.

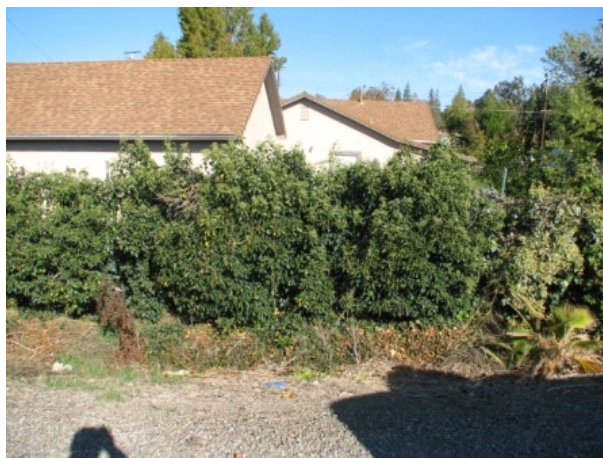
jeto_s_20110301_318.jpg

Fall 2009 photo of landscaping within 10-ft of the levee toe obstructs visibility and access.

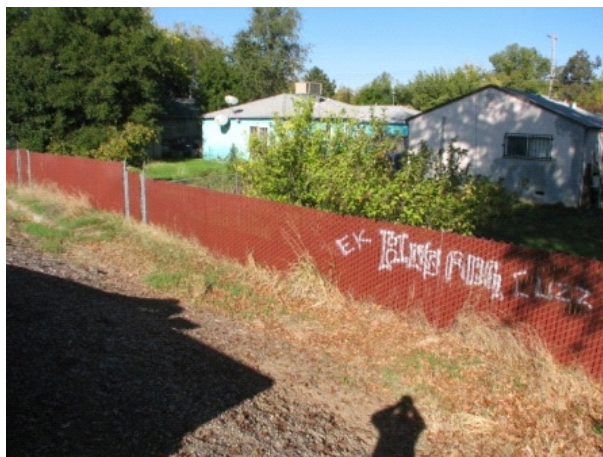
jeto_s_20110301_319.jpg

Levee Mile Report Line	31
Start Levee Mile	1.81
End Levee Mile	1.81
Location	Land Side
Category	Earthen Levee
Item	Encroachments

Fall 2009 photo of privacy fence within 10-ft of the levee toe obstructs visibility and access.

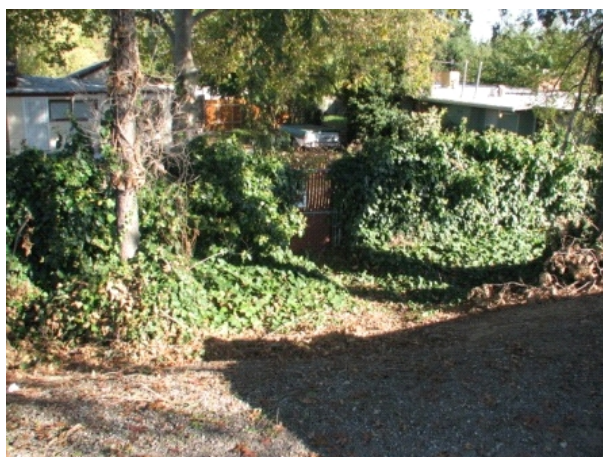
jeto_s_20110301_320.jpg

Levee Mile Report Line	32
Start Levee Mile	1.83
End Levee Mile	1.83
Location	Land Side
Category	Earthen Levee
Item	Encroachments

Fall 2009 photo of dense ivy and fence obstruct visibility and access.

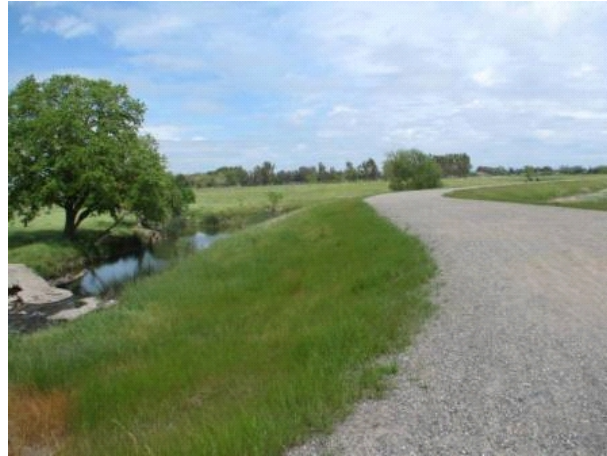
jeto_s_20110425_429.jpg

04/20/2011 Mowing has not started on this unit yet. Grass over 12" tall within 20' of the levee crown.

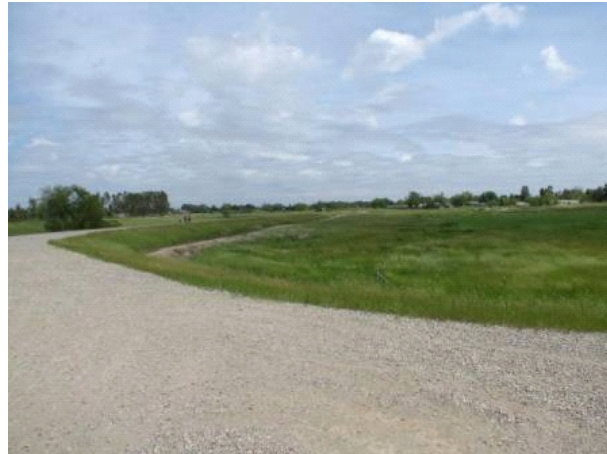
jeto_s_20110425_430.jpg

Levee Mile Report Line	2
Start Levee Mile	0.01
End Levee Mile	1.30
Location	Land Side
Category	Earthen Levee
Item	Vegetation

04/20/2011 Mowing program has not started on this unit yet. Grass over 12" tall on landside of levee inhibits visibility.

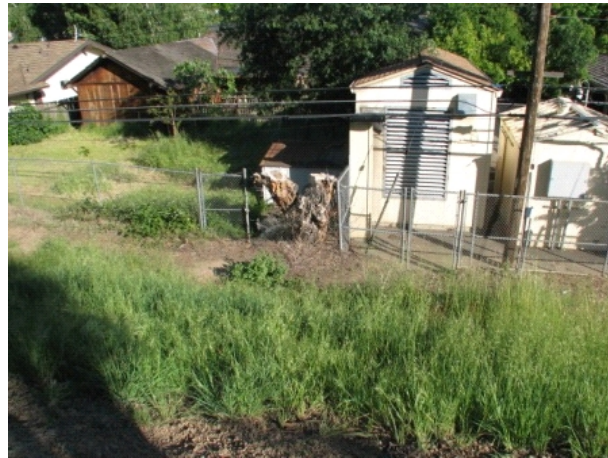
jeto_s_20110301_325.jpg

Tree trunk at fence line.

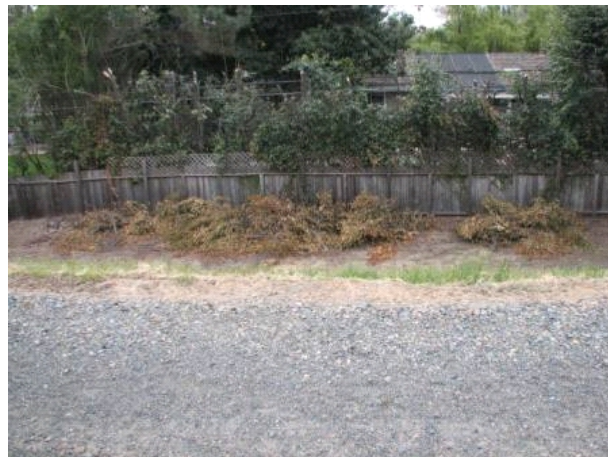
jeto_s_20110413_384.jpg

Levee Mile Report Line	2
Start Levee Mile	0.55
End Levee Mile	0.55
Location	Land Side
Category	Earthen Levee
Item	Encroachments

04/13/2011 Letter has already been sent to owner by ARFCD, Superintendent will follow up with second letter.

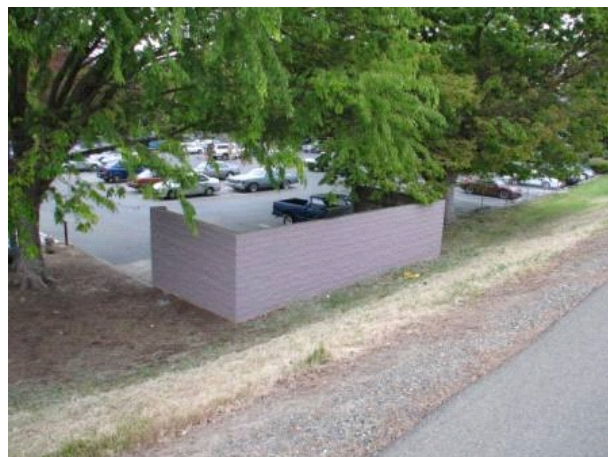
jeto_s_20110413_385.jpg

Levee Mile Report Line	4
Start Levee Mile	1.75
End Levee Mile	1.75
Location	Land Side
Category	Earthen Levee
Item	Encroachments

4/13/3011 Cinderblock trash enclosure is encroaching in the toe of the levee.

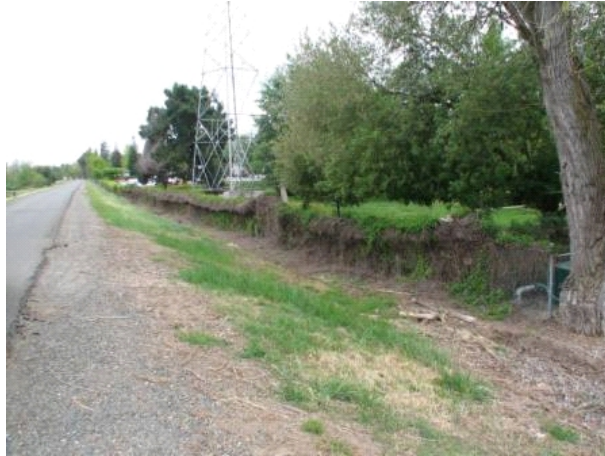
Levee Mile Report Line	6
Start Levee Mile	3.11
End Levee Mile	3.24
Location	Land Side
Category	Earthen Levee
Item	Encroachments
04/13/2011 Plants are being trimmed, but still obstructs visibility.	
jeto_s_20110413_386.jpg

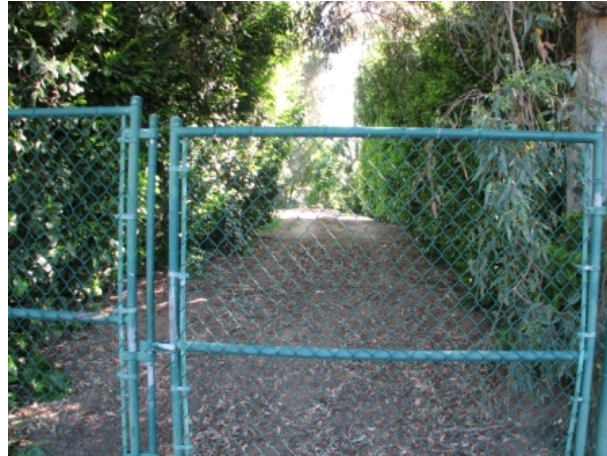
jeto_s_20110301_327.jpg

Levee encroached on by property owners north of Arden.

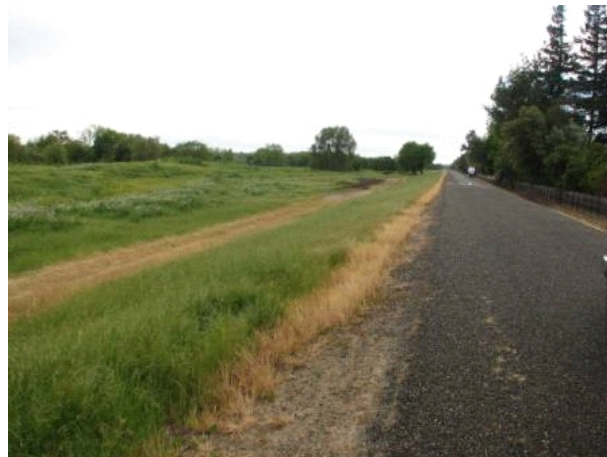
jeto_s_20110413_383.jpg

Levee Mile Report Line	3
Start Levee Mile	1.82
End Levee Mile	1.94
Location	Water Side
Category	Earthen Levee
Item	Vegetation

Vegetation taller than 12" is present on this stretch which was improved by the USACE. Per comment from ARFCD superintendent, this area is to be maintained by USACE.

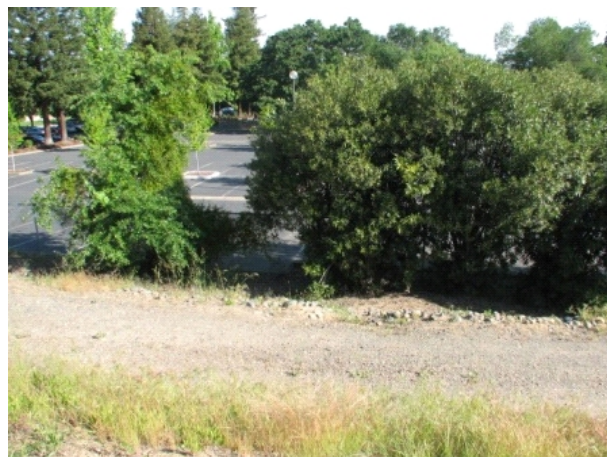
jeto_s_20110301_326.jpg

Levee Mile Report Line	4
Start Levee Mile	3.58
End Levee Mile	3.58
Location	Land Side
Category	Earthen Levee
Item	Encroachments

Trees at fence line obstruct access and visibility.
